Subject: Department of Natural Resources Washington Geological Survey,  
School Seismic Safety Assessment Project, Contract No. AE 410 -  
Seismic Evaluation for **Raymond School District**

### **School Buildings Evaluated in the Raymond School District**

1. Raymond Elementary School, Raymond Elementary
2. Raymond Junior Senior High School, Main Building

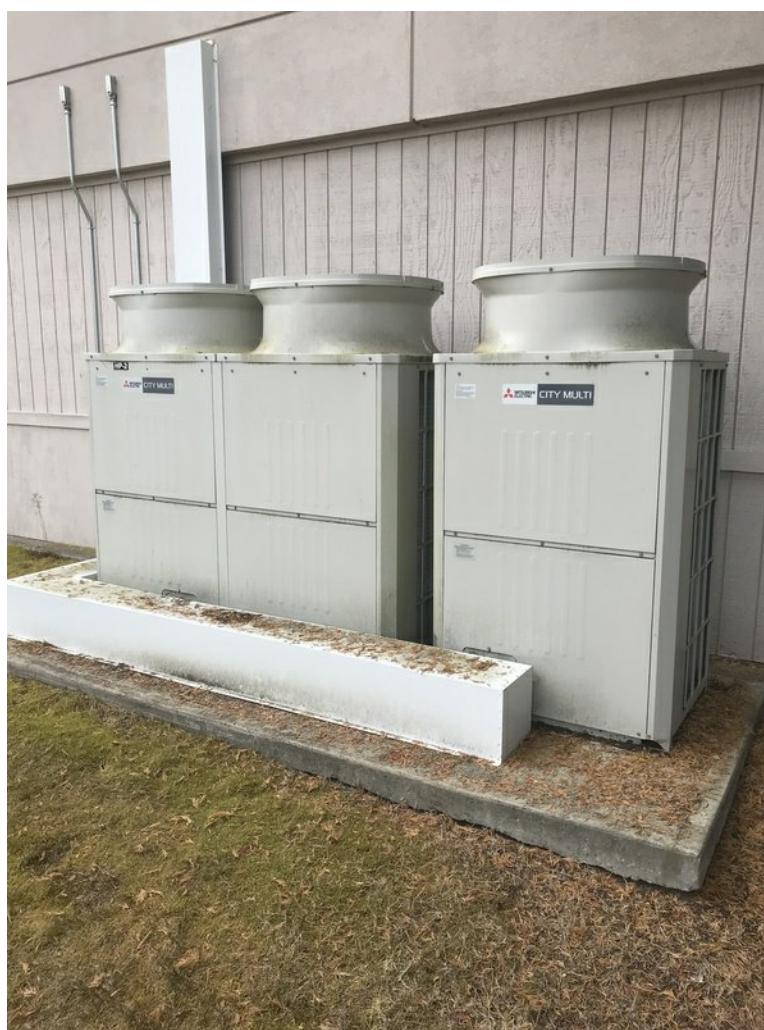
**Figure 1-2. Unbraced Mechanical Equipment**

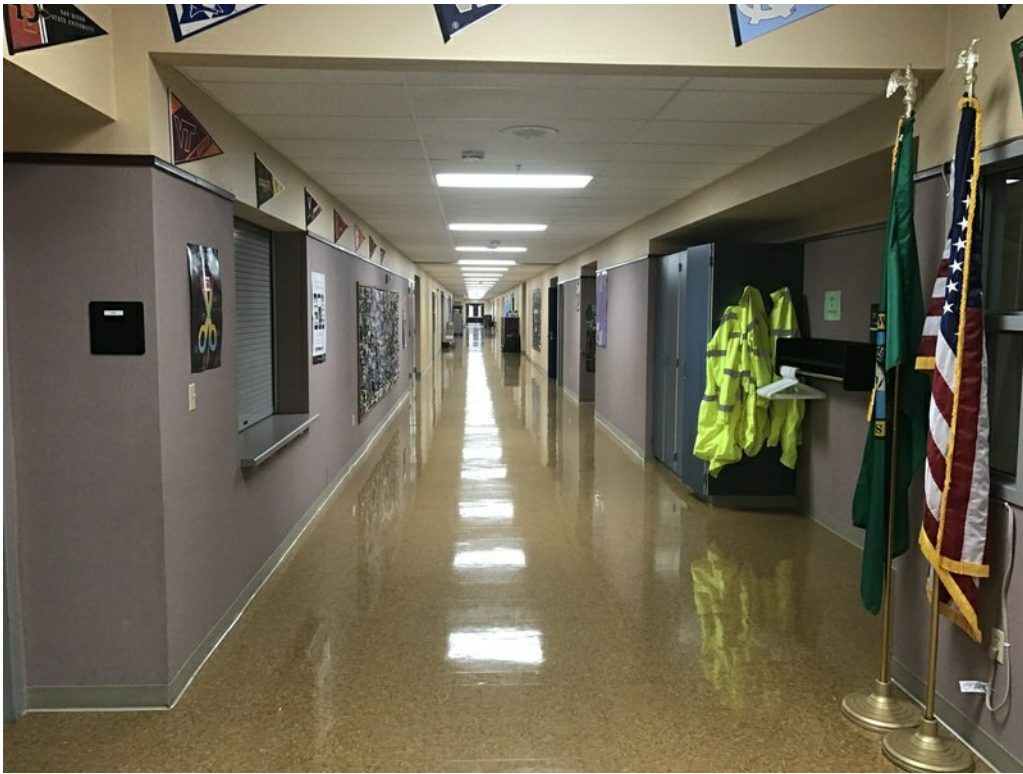
**Figure 1-3. Typical Hallway with Unknown Light Fixture Bracing**

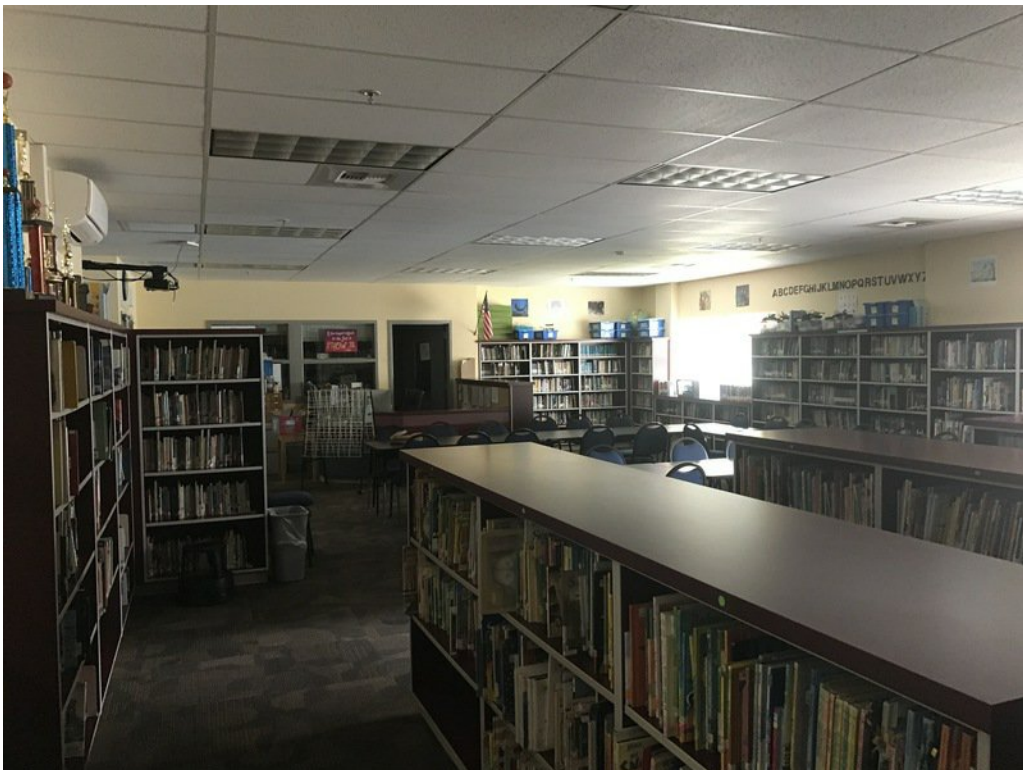
**Figure 1-4. Library with Unbraced Bookshelves**

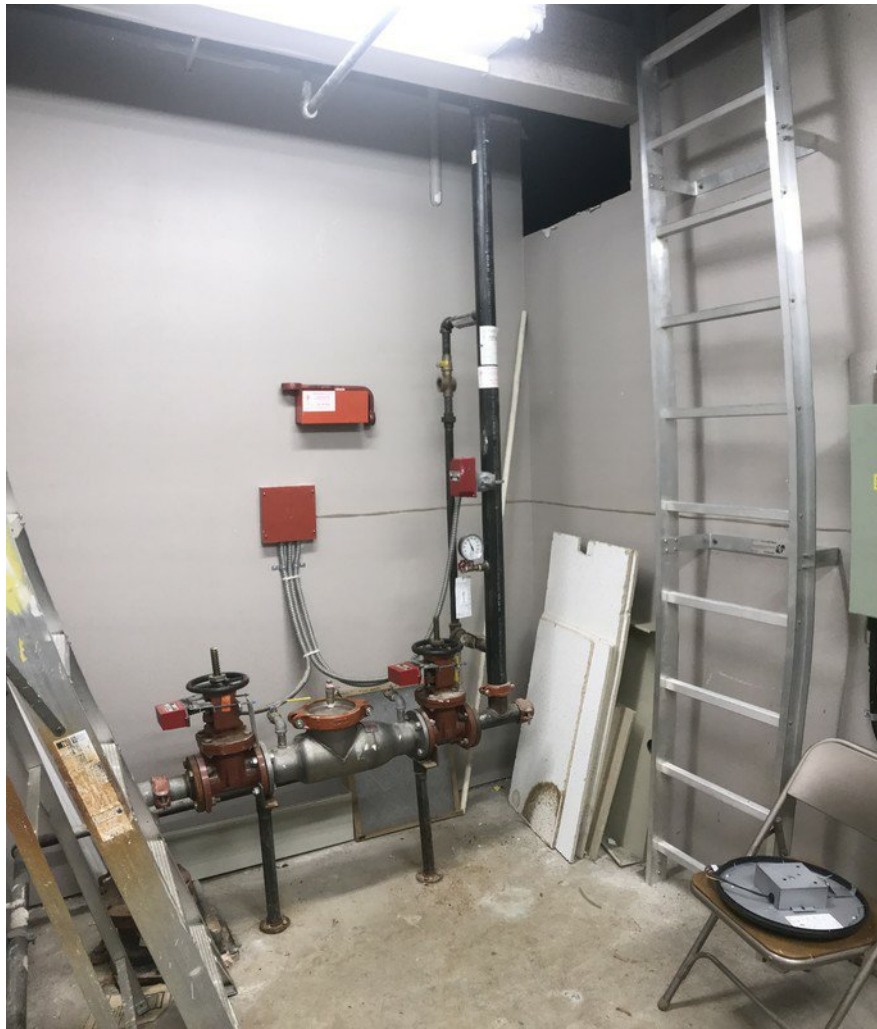
**Figure 1-6. Fire Riser and Fire Piping has Unknown Bracing**

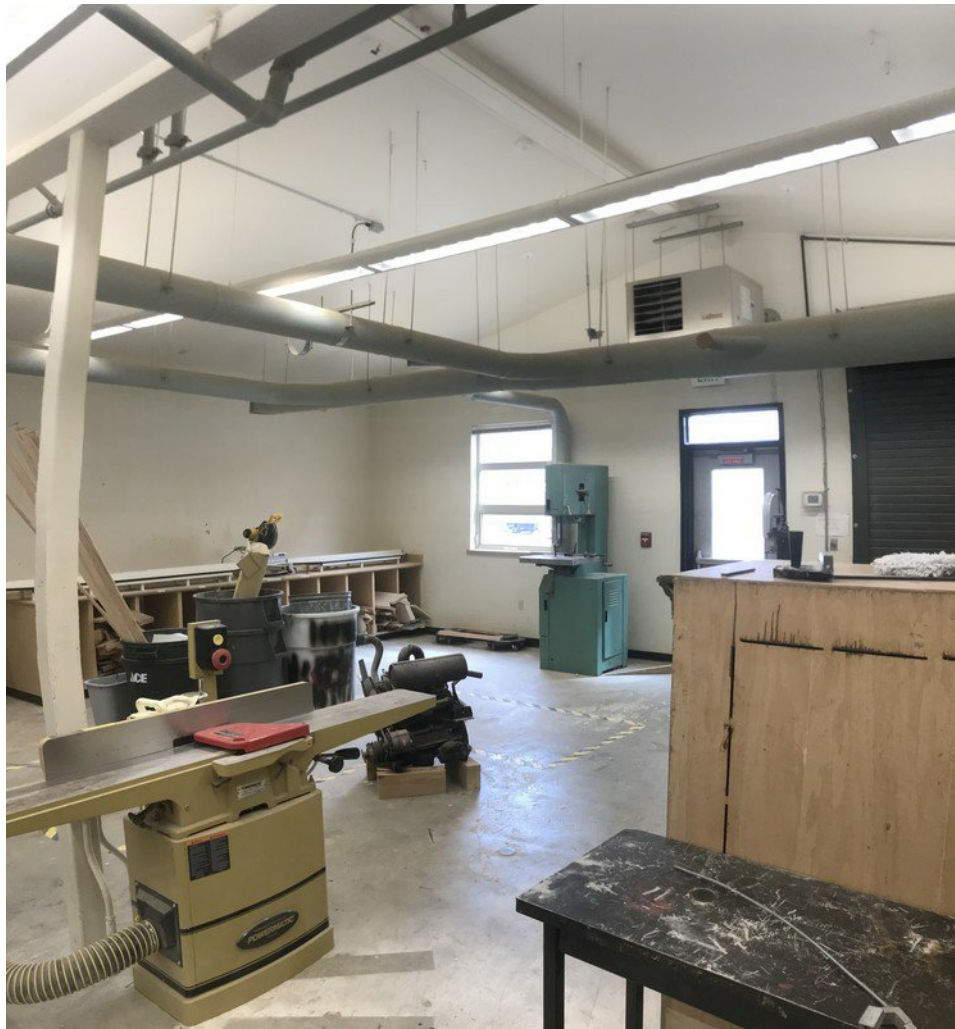
**Figure 1-2. Wood Shop with Suspended Equipment and Piping Over Exit**

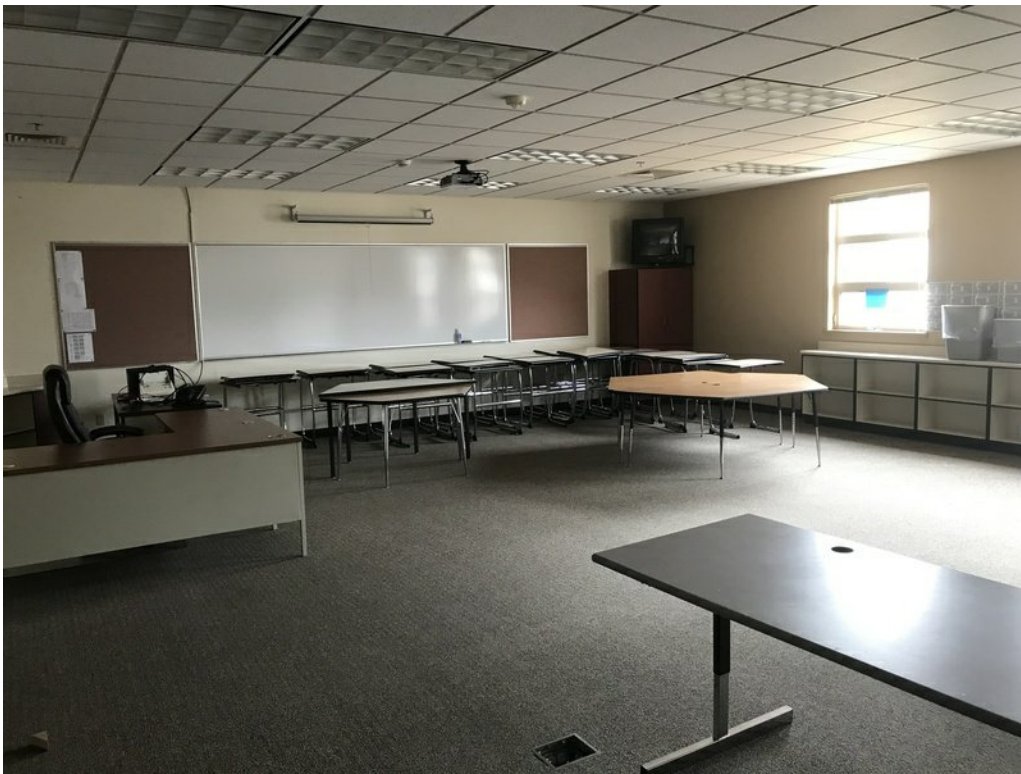
**Figure 1-9. Typical Classroom with Inadequate Light Fixture Bracing**

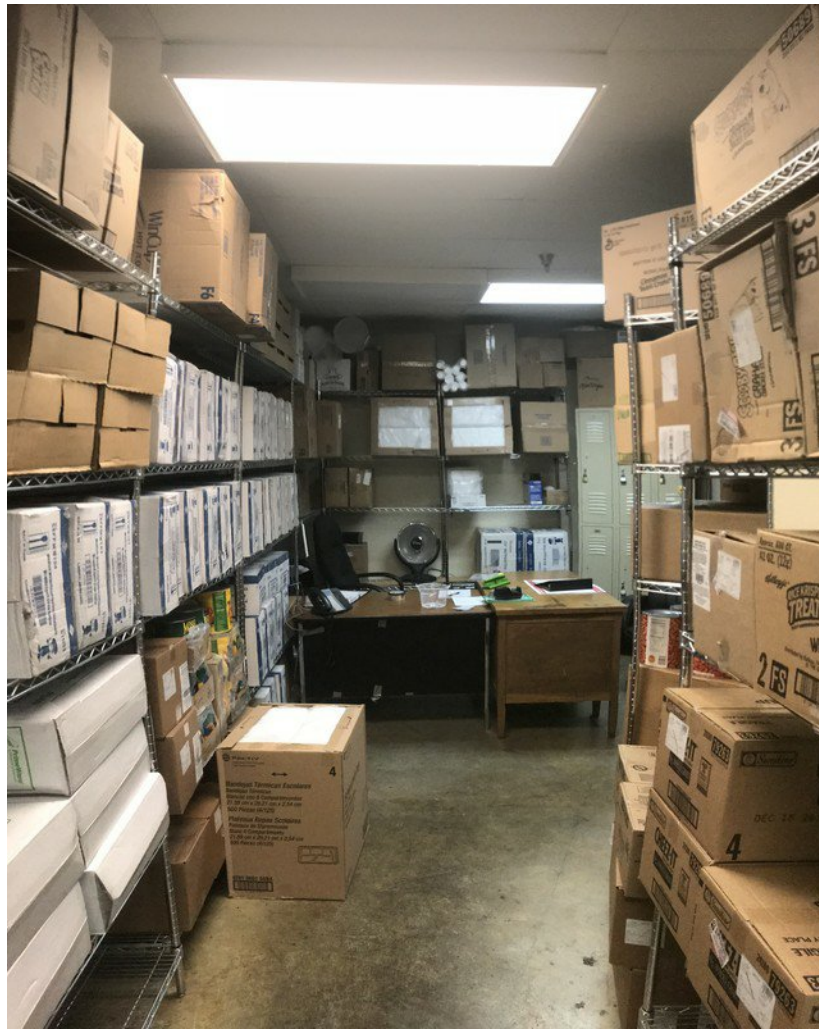
**Figure 1-10. Unbraced Tall Narrow Contents, Typical**
